Degradation of Boral in Spent Fuel Pool at Taiwan's BWR NPPs

Gung-Min Ho
Section Chief

Department of Nuclear Regulation
Atomic Energy Council, Taiwan

March 13, 2014

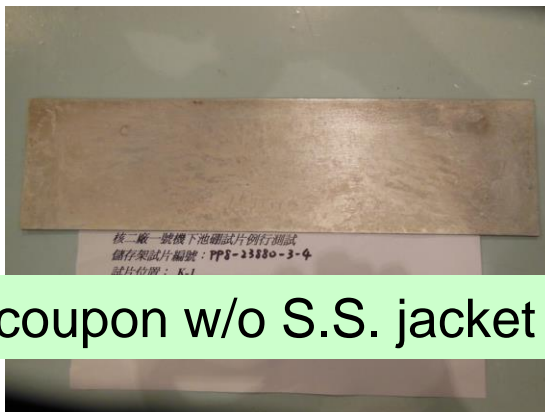
- Unlike the coupons of Chinshan, the Holtec Boral coupons at Kuosheng are jacketed in stainless steel.
- The non-jacketed coupons of the other manufacturer, ENSA, at Kuosheng had shown noticeable blisters, which is similar to Chinshan's operating experience

coupon w/o S.S. jacket
